# **Debris/Ice/TPS Assessment and Integrated Photographic Analysis of Shuttle Mission STS-101**

**DEBRIS/ICE/TPS ASSESSMENT  
AND  
INTEGRATED PHOTOGRAPHIC ANALYSIS  
OF  
SHUTTLE MISSION STS-101**

**19 May 2000**

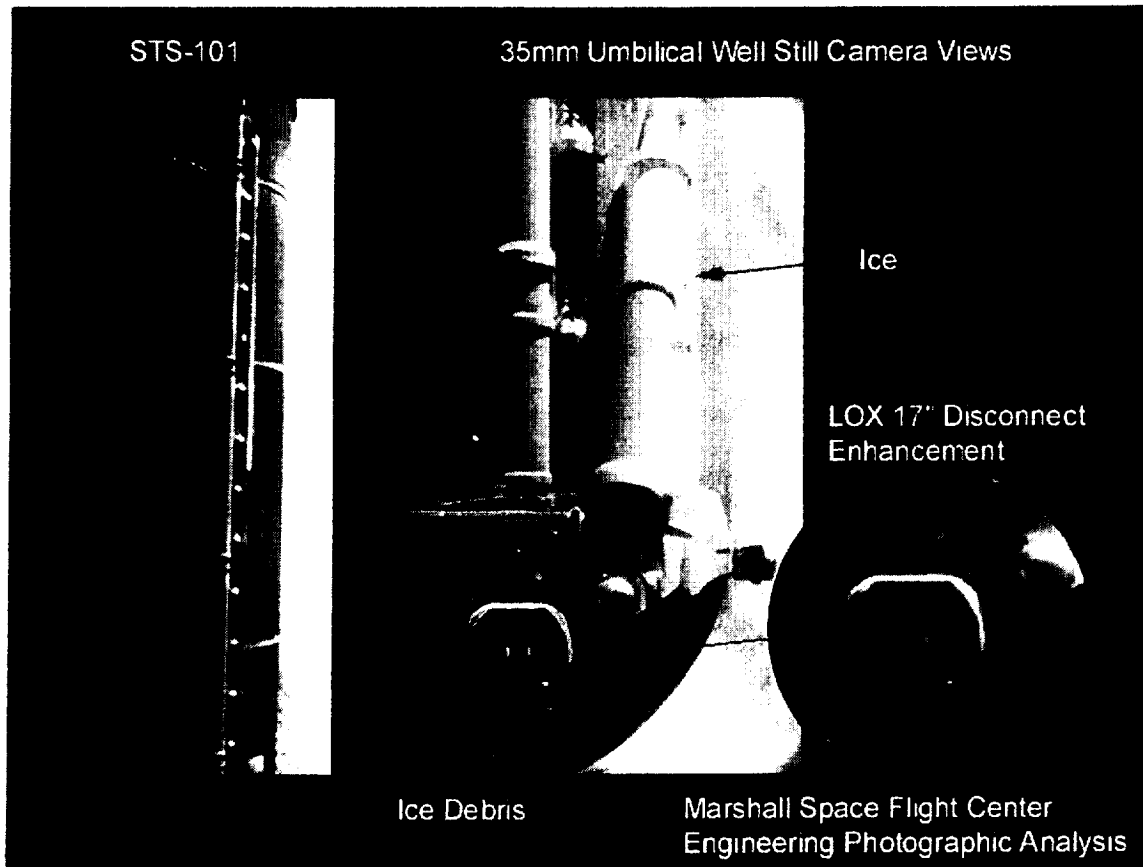
**Figure 13 Umbilical Well 35mm Still Camera**

Ice was observed on the ET after separation, as noted in the frame below. Because of a late +X translation, the forward portion of the ET was not imaged by the still camera. Image fog degraded several of the last exposures on the 35mm film roll, creating a reddened cast to the images.

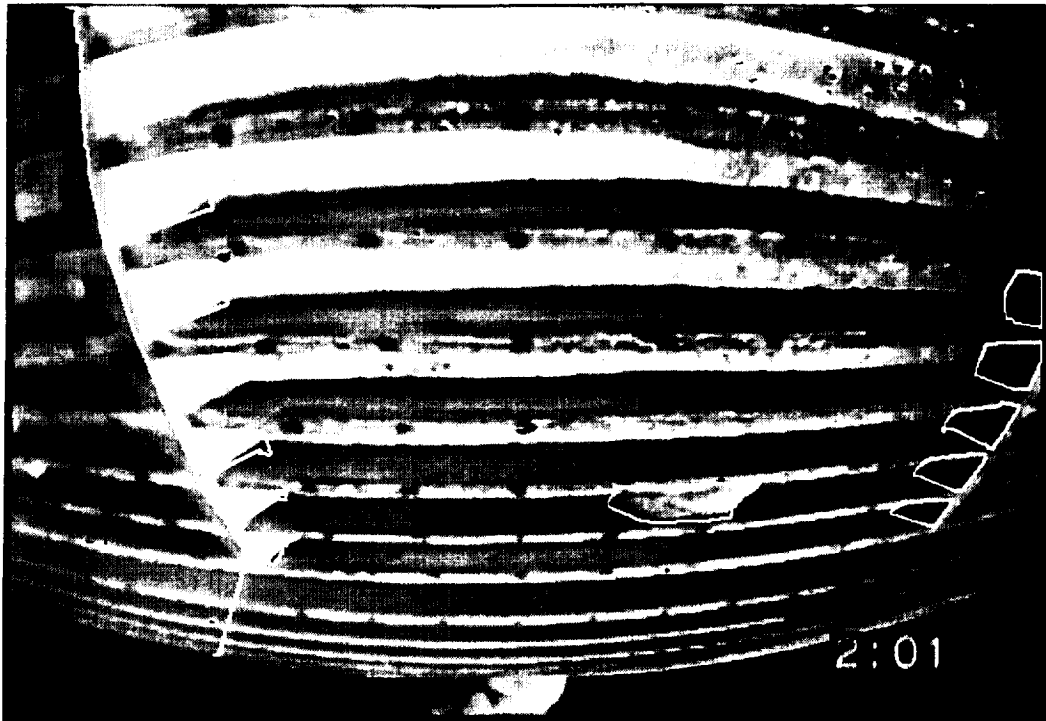
Figure 14. STS-101 -Y Thrust Panel

Figure 14 illustrates all tabulated foam loss events on the -Y Thrust Panel of the ET for flight STS-101. White lines in the figure enclose vented areas. There were 100 total foam loss events recorded. The number of events recorded during each 0.5 second time interval and the total number of events from approximately T+90.0 seconds are shown in Figure 15. Using a fourth order polynomial approximation to trend the count data, the maximum foam loss activity appears to peak just after T+ 110.0 seconds. The maximum number of events recorded during any 0.5 second time interval was seven. Figure 16 and Table 3 compare vented and non-vented areas.

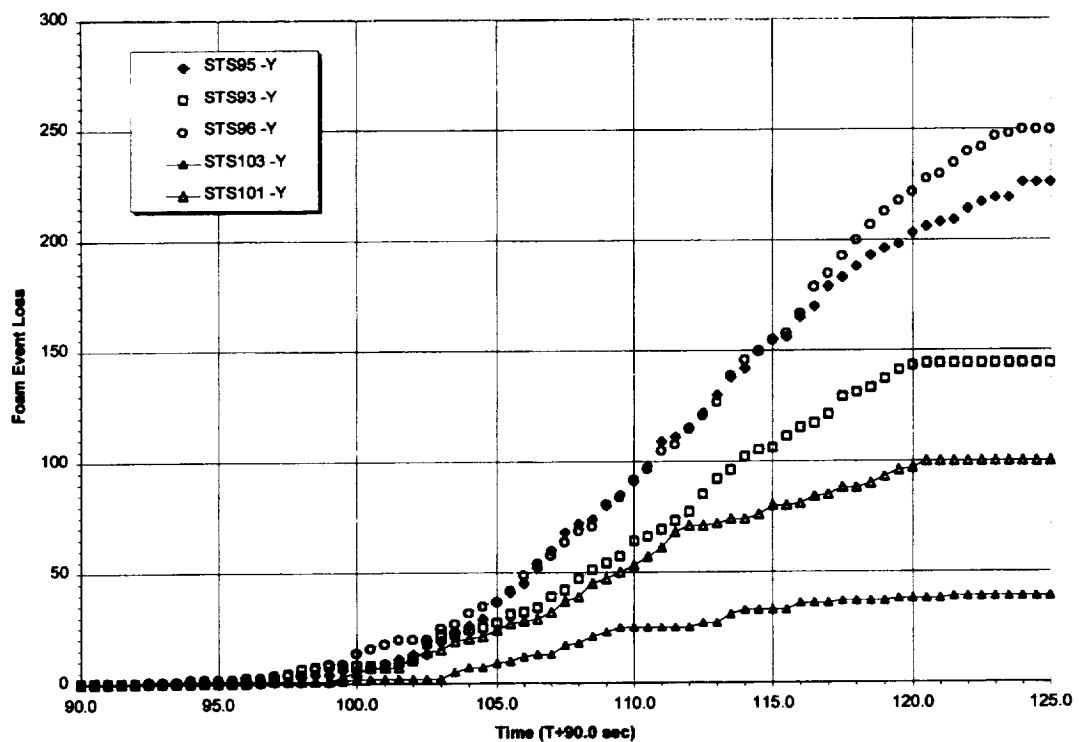
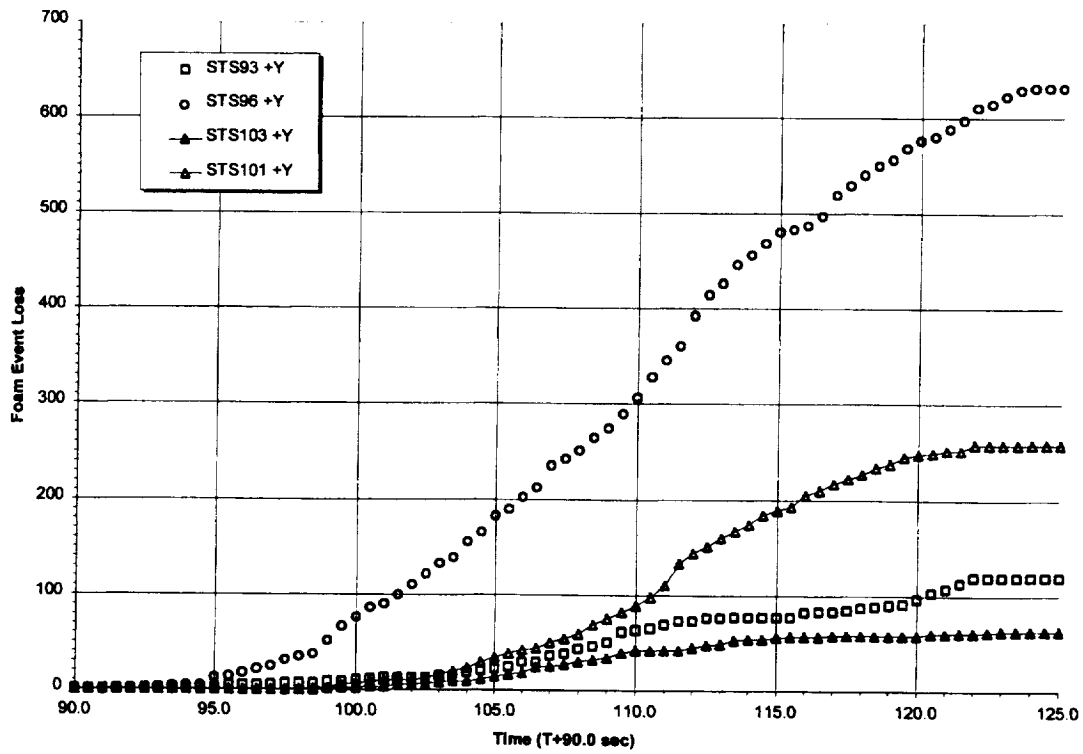
The foam loss events from the -Y thrust panels are bounded by a maximum of approximately 250 total events. The foam loss events from the +Y thrust panels are bounded by a maximum of approximately 650 total events. This maximum was achieved on mission STS-96 where a majority of the foam loss events recorded by the right SRB camera were noted to be in areas of the +Y thrust panel that were not vented.

No venting of the ET foam was performed for mission STS-95 and partial venting for STS-96 and STS-93. More extensive venting was done for Missions STS-103 and STS-101. The noticeable reduction in foam loss events in STS-103 and STS-101 is most probably attributable to the venting of more extensive areas of the thrust panels.
